# Church Roof Replacement using Terne-coated Stainless Steel

Guidance Note

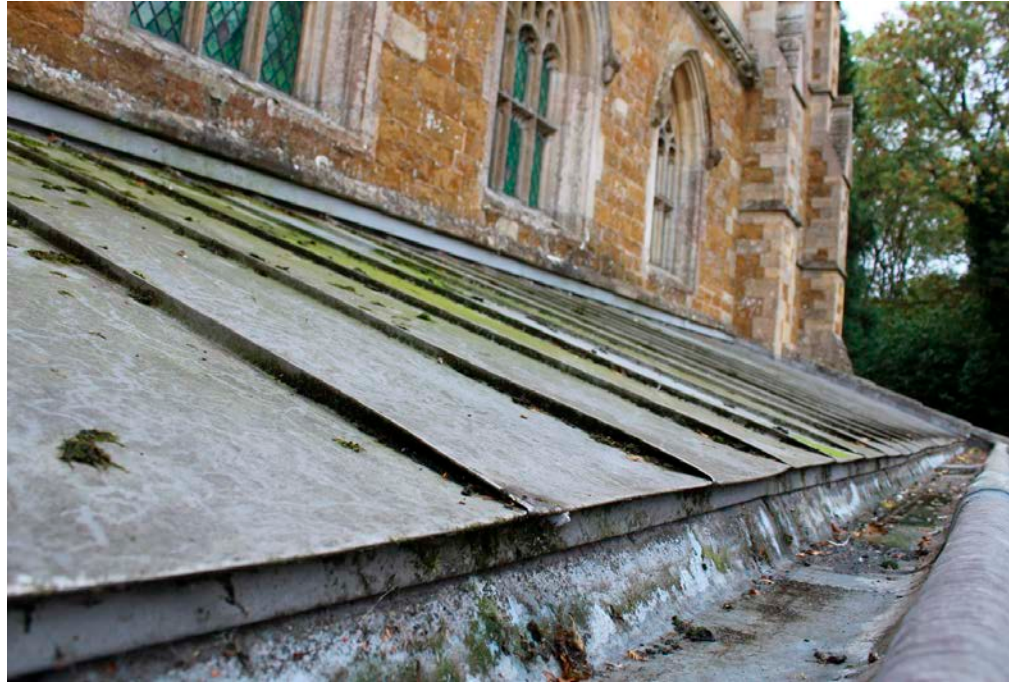
Figure 1:  
Standing seams

There are two common means of forming side joints in stainless steel metal roofing: a standing seam and a round batten roll.

The 25mm high standing seam has a double-welted top. The minimum finished slope for this type of joint is 5°. In some exposed locations with long shallow slopes, water has found its way through the seams by capillary action or potentially by wind and thermal pumping action. This phenomenon is a result of wind pressure and temperature changes on partially sealed seams. Many contractors now apply a butyl seal within the seam before closing up. However the seal, which is inaccessible once the roof is properly formed, can have a relatively short life expectancy of typically 10 years.

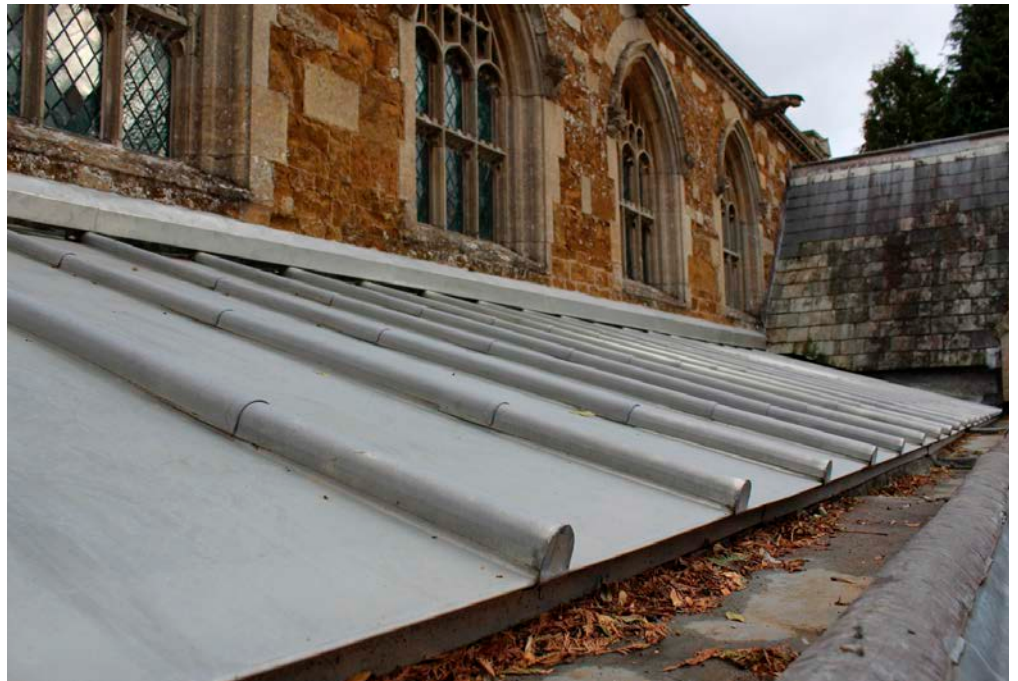
Figure 2:  
Round batten rolls

The alternative method of forming a side joint is to use a batten roll detail. The minimum finished slope for this type of joint is 3°. The sides of each stainless steel pan are dressed up the sides of a 50 x 50mm shaped timber batten. The up-turns at the sides of the panels are 40mm high, so there is less risk of rainwater entry than with a standing seam, whilst allowing the joint to breathe. The batten and up-turns are then protected with a separate stainless-steel capping strip dressed to shape and fitted over the batten.

Battens can be formed in different shapes. The round batten roll closely resembles the traditional lead roll. An alternative preferred by some architects is a square batten with the capping held in place with welted edges, although this does not replicate the appearance of a traditional lead roll.

Stainless steel cleats hold the sheets down and prevent detachment of the lightweight material in strong winds. The means of attachment also allow long lengths of sheet metal to expand and contract along the length of the roof slope. As there is less work-hardening in forming a batten roll compared to a standing seam the risk of creating unevenness in the flat pan of the sheet, known as quilting or oil canning, is reduced.

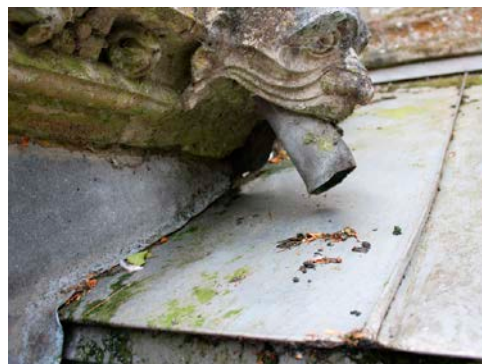
Figure 3:  
Awkward detail at verge with water  
running into upstand

Some rainwater ingress has been observed at verges and below sloping valleys where it has not been possible to form and dress irregular-shaped panels in stainless steel on site. This could be resolved by preparing a special panel in a workshop. Alternatively, for relatively small areas, the detail work around roof edges could be formed in lead. Although this could be attractive to a thief, on a typical roof more than 95 per cent of the roof covering would still be formed in the terne-coated stainless steel and at very low risk of theft.

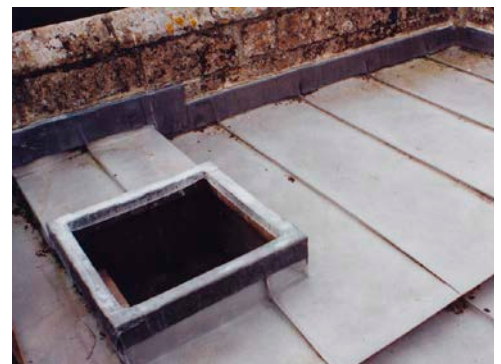
Figure 4:  
Lead used for flashings and access  
hatch capping

Other awkward details such as around pipe penetrations and access hatches could also be formed in lead. Lead remains the preferred material for flashings dressed into masonry. Where possible, standard details should be adopted and agreed in advance.

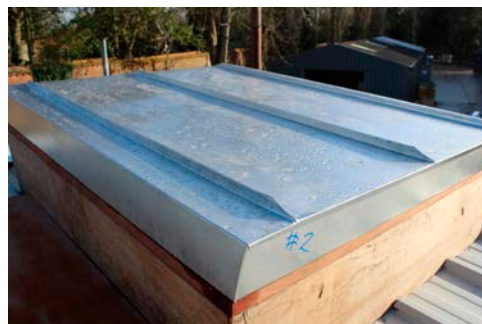
Figure 5:  
Standing-seam roof sample under test

A recurring concern has been reports during heavy rainfall of significant noise heard within churches caused by droplets of rain falling onto the thin metal roofing. There is a British Standard for the laboratory measurement of sound generated by rainfall on building elements, BS EN ISO 140 Part 18. Rain is simulated on a purpose-built rig at the acoustic laboratory. Droplets of water fall from a tank suspended 3.5m above small sample roofs and the sound intensity is measured within a test room directly below.

Acoustic tests were commissioned by Historic England to compare different roof constructions. The acoustic performance of the two different TCSS seam types - standing seam and round-batten rolls - was measured. The independent test results found that the average sound intensity below the batten roll roof was 1.3 dB quieter than beneath the standing seam roof.

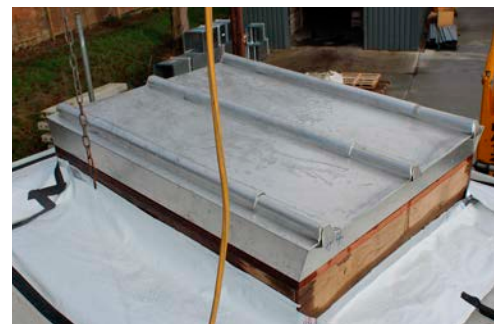
Figure 6:  
Round batten-roll roof sample under test

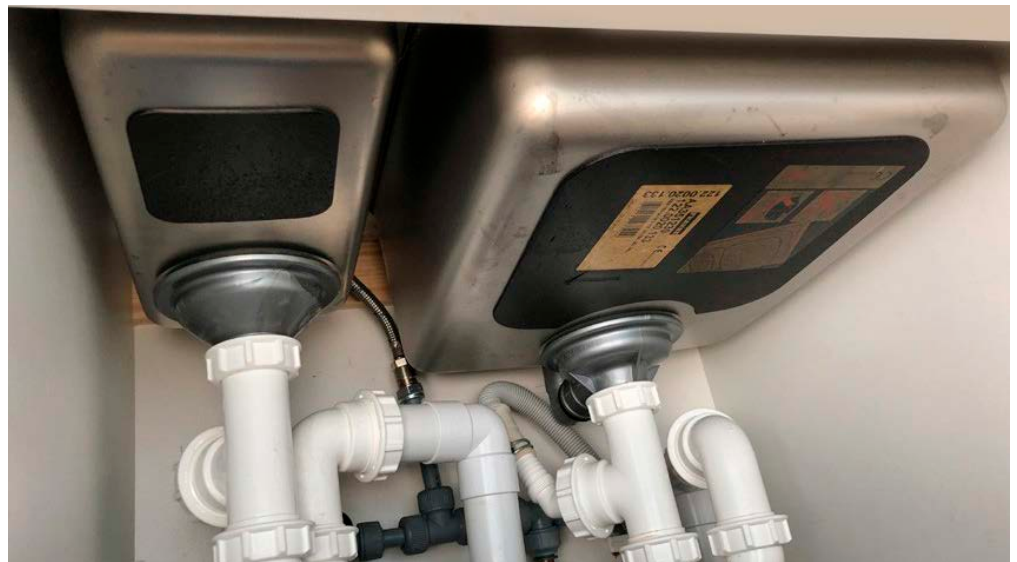
Figure 7:  
Mats bonded to underside  
of sink to reduce dripping  
noises

There are two types. A spiral-mesh open-fibre mat approximately 8 mm thick with a breather membrane directly below. The shallow air gap helps to reduce noise transmission. Alternatively, a solid acoustic mat that is adhered to the underside of the flat pan of the roofing can be used. This uses the same technique as that used to reduce the noise of drops of water from a dripping tap falling into the bowl of a stainless-steel sink.

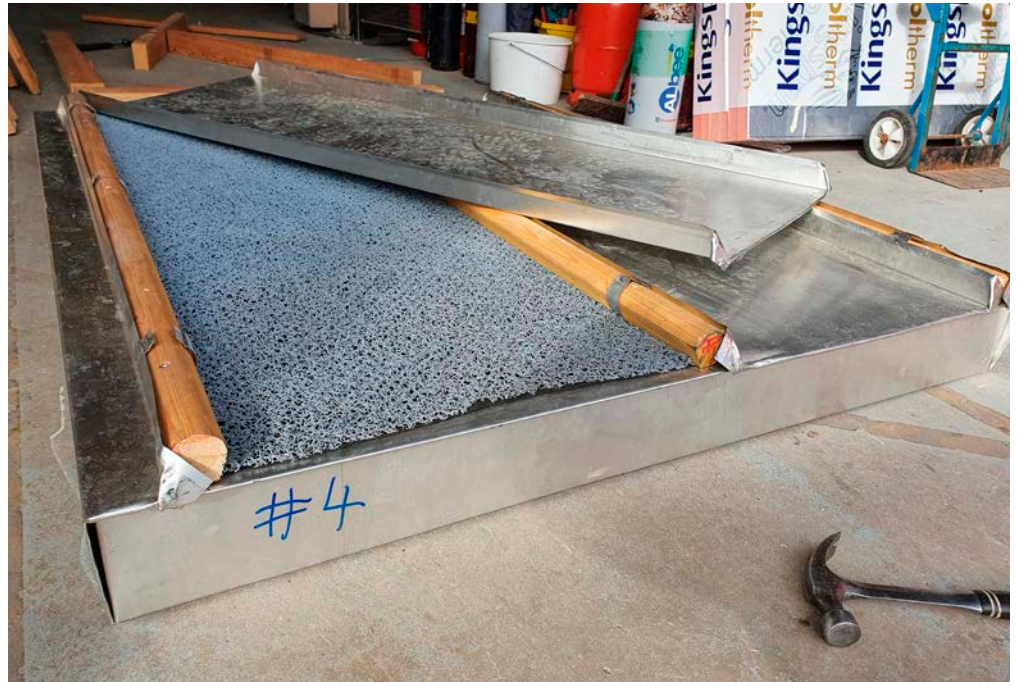
Figure 8:  
Spiral mesh underlay  
under test

Independent tests carried out at the acoustic laboratory found that the addition of spiral-mesh open-fibre underlay reduced the sound intensity by 0.4 dB. The alternative solid acoustic mat reduced the sound intensity by 2.2 dB.

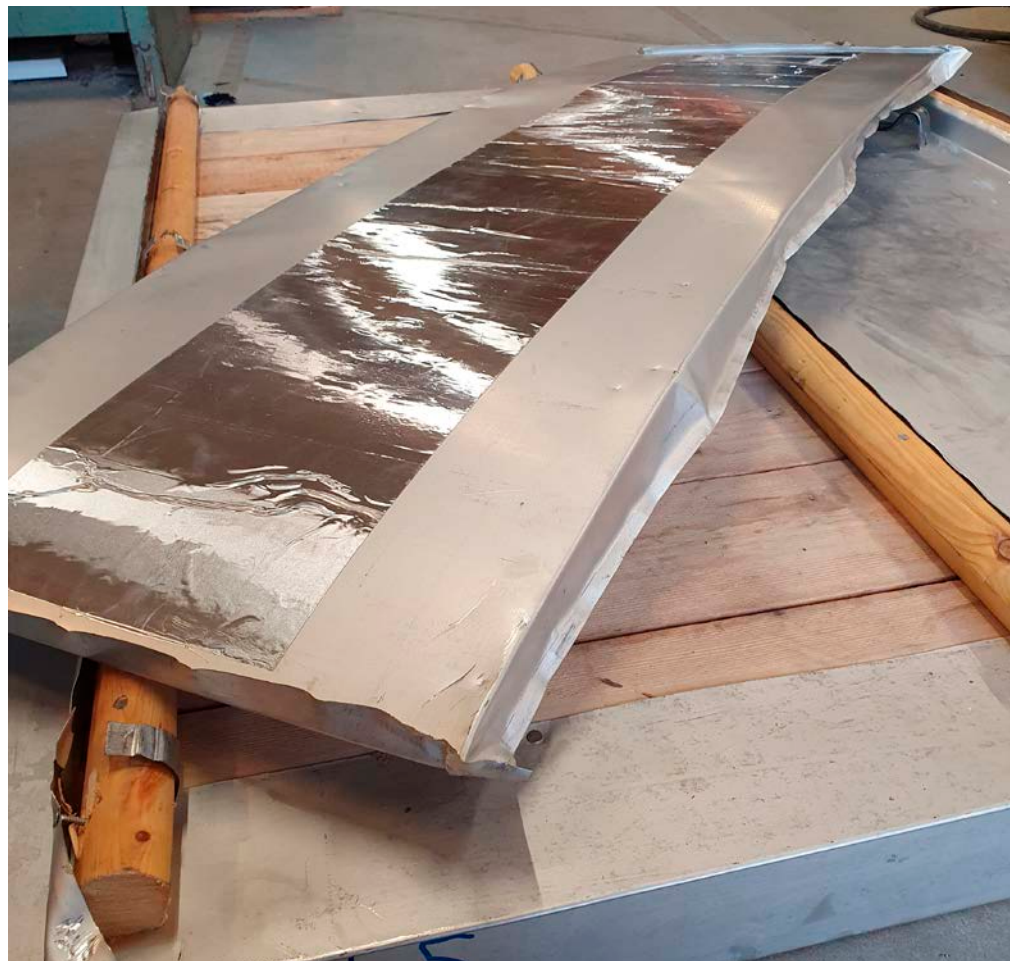
Figure 9:  
Acoustic mat bonded to  
underside of roofing for  
acoustic test

Suggest an acoustic mat adhered to the underside of the flat pan of the roofing as quieter in heavy rainfall.

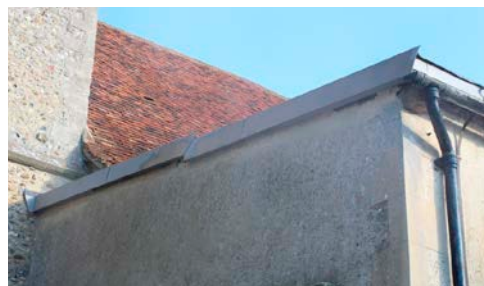
Figure 10:  
Straight verge fascia contrasts with uneven masonry

On occasion perimeter detailing to the stainless steel roofing can be readily seen from ground level and if not properly considered can create an unacceptable appearance.

Care is required in considering perimeter details that can be seen from ground level. Alternative details using traditional materials such as stone or rendered masonry may be feasible. Alternatively, forming the verge in lead could be considered, although again this could be attractive to a potential thief.

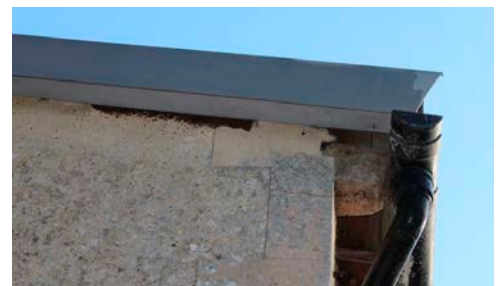
Figure 11:  
End of fascia with acute corner and incomplete closure

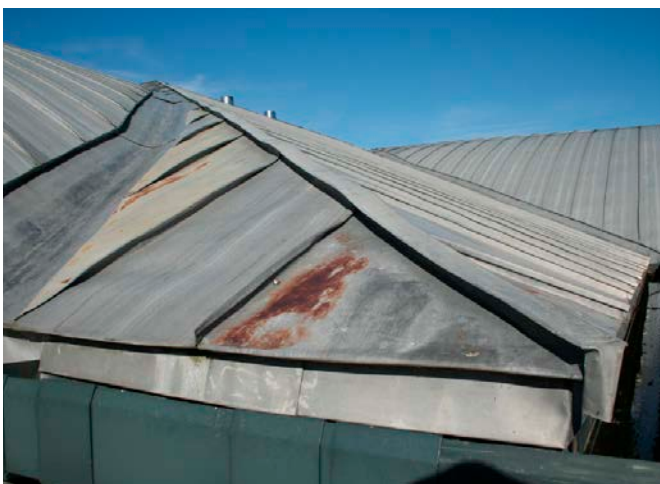
Figure 12:  
Discolouration of lead-rich terne-coated stainless steel

On a few stainless steel roofs with the old lead/tin terne coating, a brown-coloured residue formed after several years of exposure. On investigation it was found that there was no reduction in the overall thickness or pitting corrosion in the stainless steel roofing. Trials have shown that the discolouration can be permanently removed using a weak phosphoric acid solution that is commonly found in carbonated soft drinks, especially cola.

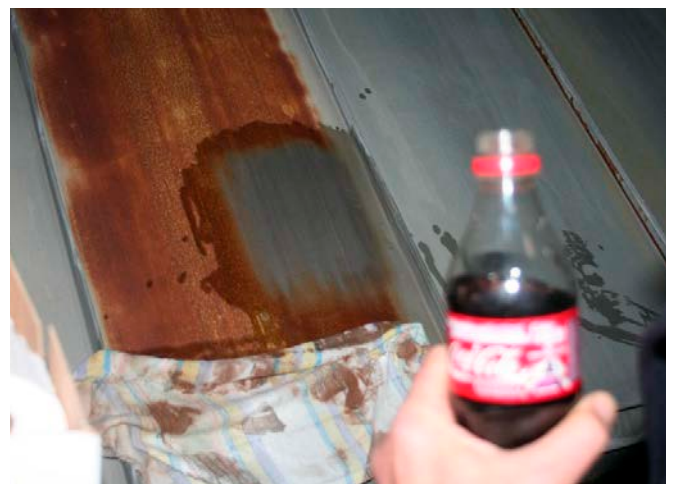
Figure 13:  
Stain successfully removed using weak phosphoric acid solution

If discolouration appears, wash down with recommended cleaning solution.
